Report and recommendations relating to the Severe Flood Event in Selly Park South on 6th September 2008

Compiled for Selly Park South Neighbourhood Forum, Birmingham City Council and the Environment Agency by John Clayton, B.Ed Geography (Birmingham University), FRGS, Assoc F.RMetS. Specialist areas: Meteorology, Hydrology and Fluvial Processes. Currently working for the Royal Meteorological Society. Report approved by John Williams (Chair) & Jeanne Glenn (Secretary) on behalf of Selly Park South Neighbourhood Forum and published 16th September 2008

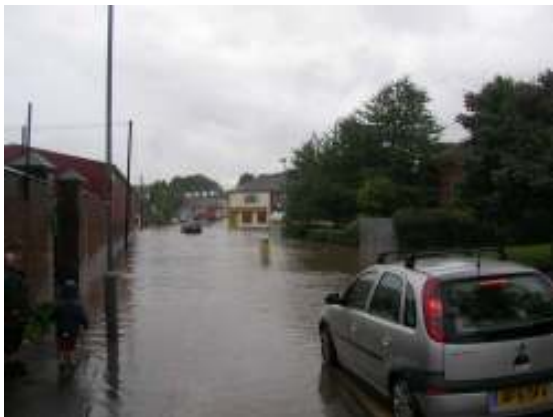
Dogpool Lane at 15:37BST

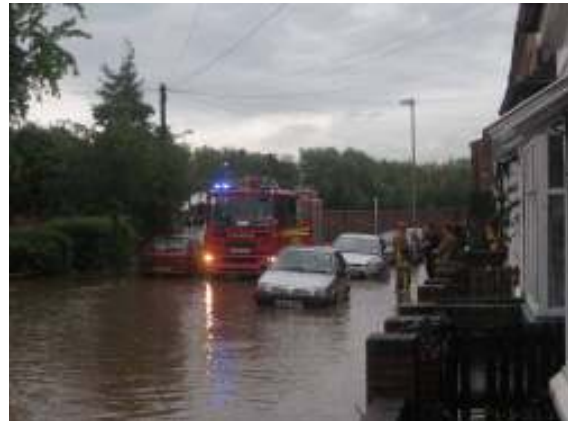
Fashoda Road at 17:19BST

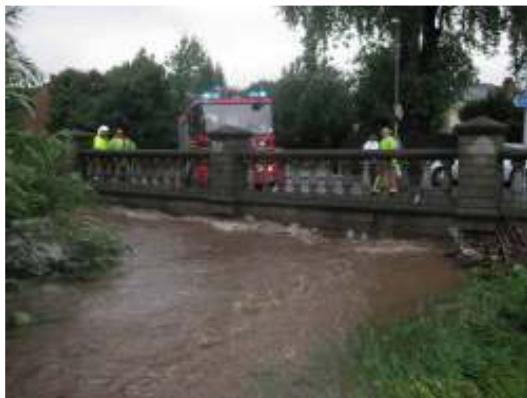
Dogpool Bridge at 17:05BST

During the peak of the flood which lasted for a couple of hours the channel below Dogpool Bridge was at full capacity with the floodwater above the top of the bridge arch and not far short from overspilling onto the road. Presumably the reason the water rose no further up the bridge was because it was taking the diversionary route to the west instead, as described above. The drains in Dogpool Lane and the southern ends of Fashoda Rd and Cecil Rd were completely incapable of dealing with the large volume of flood water and surface run-off involved.

1. Construct flood protection bund on the western side of the Rea from Dogpool Lane to Cartland Road to prevent the floodwater from taking the diversion it followed on 06.09.2008.
2. Reconstruct Dogpool Bridge to increase the arch span to allow flood discharges similar to those of 06.09.2008 to flow through without obstruction.
3. Minor improvements to the flood defences at the southern end of the bund which protects the rear service road and the houses on the eastern side of Cecil Road.

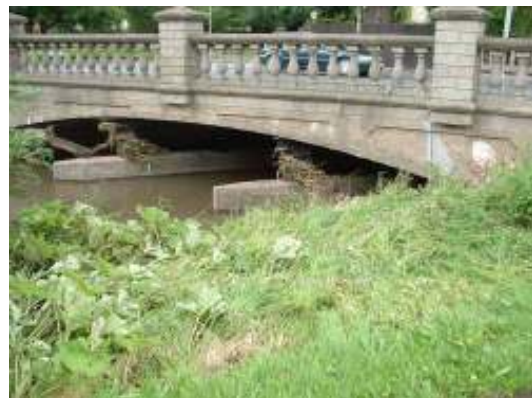
Dogpool Bridge two days later
